# Manhole Inspection Summary

## Manhole # S11KK1025MH

Insp Date: **5/29/07 11:41 AM**

**Location** Address: **4601 SUMTER AVE**

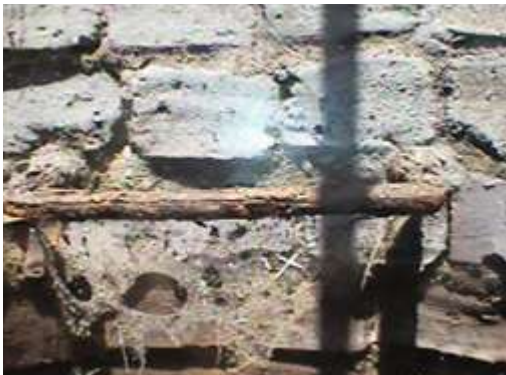
Defect 1

Count: **5** Missing: **0** ☒ **Corroded**

CORRODED RUNG

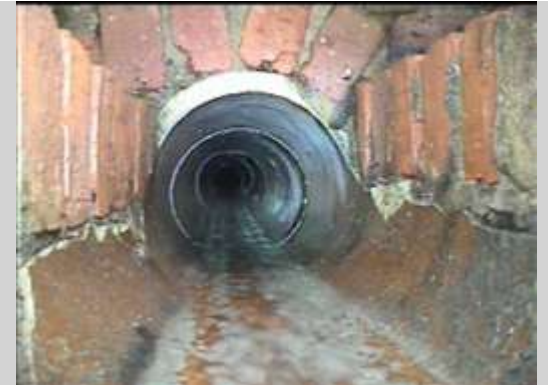
12 O'Clock Outflow

8 in. Circular Gravity Sewer  
Pipe Out @ 12 O'Clock

Pipe Height: (in.) Direct  
Pipe Material: **Clay** ☐ Pipe Lined  
Invert Depth: **10.32** (ft.) Flow Characteristics: **Slow**  
Deposits: ☒ None ☐ Mud ☐ Sludge ☐ Debris ☐ Grease  
Silt Depth: (in.) Deposits Extent:  
Infiltration: **None** Pipe Seal Cond: **Sound**

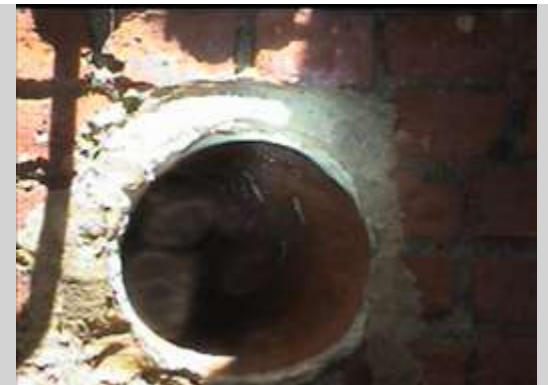
3 O'Clock Inflow

8 in. Circular Gravity Sewer  
Pipe In @ 3 O'Clock

Pipe Height: (in.) Direct  
Pipe Material: **Clay** ☐ Pipe Lined  
Invert Depth: **6.05** (ft.) Flow Characteristics: **Slow**  
Deposits: ☒ None ☐ Mud ☐ Sludge ☐ Debris ☐ Grease  
Silt Depth: (in.) Deposits Extent:  
Infiltration: **None** Pipe Seal Cond: **Sound**

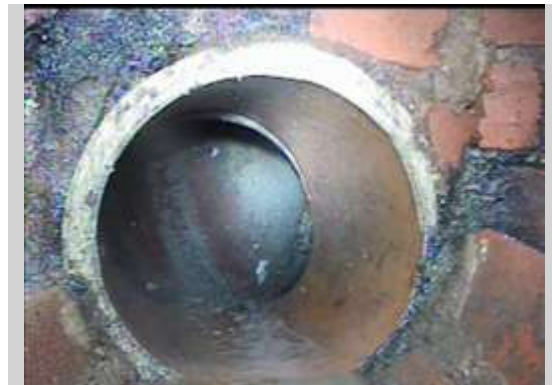
Drop In @ 3 O'Clock

Drop: **Outside Direct**  
Angled: Reading: (ft.)  
Inv Depth: **9.60** (ft.)  
Drop Condition: **Open**

Connects To: **Dead End**

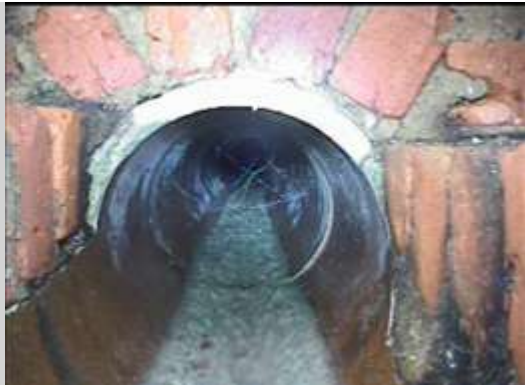
6 O'Clock Inflow

Infiltration: **None** Pipe Seal Cond: **Cracked**

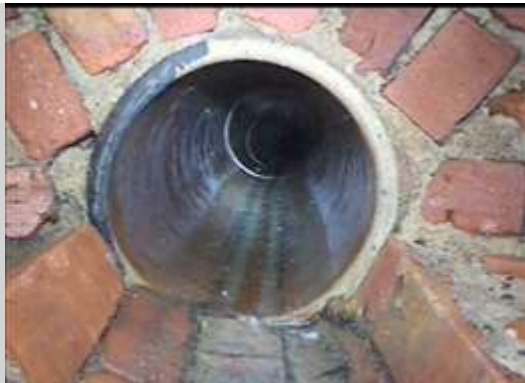
9 O'Clock Inflow

Infiltration: **None** Pipe Seal Cond: **Sound**

Connects To: **Dead End**
